FORENSICS - SINKHOLE DAMAGE TO BUILDING

Thomas Sputo, Ph.D., P.E., S.E.

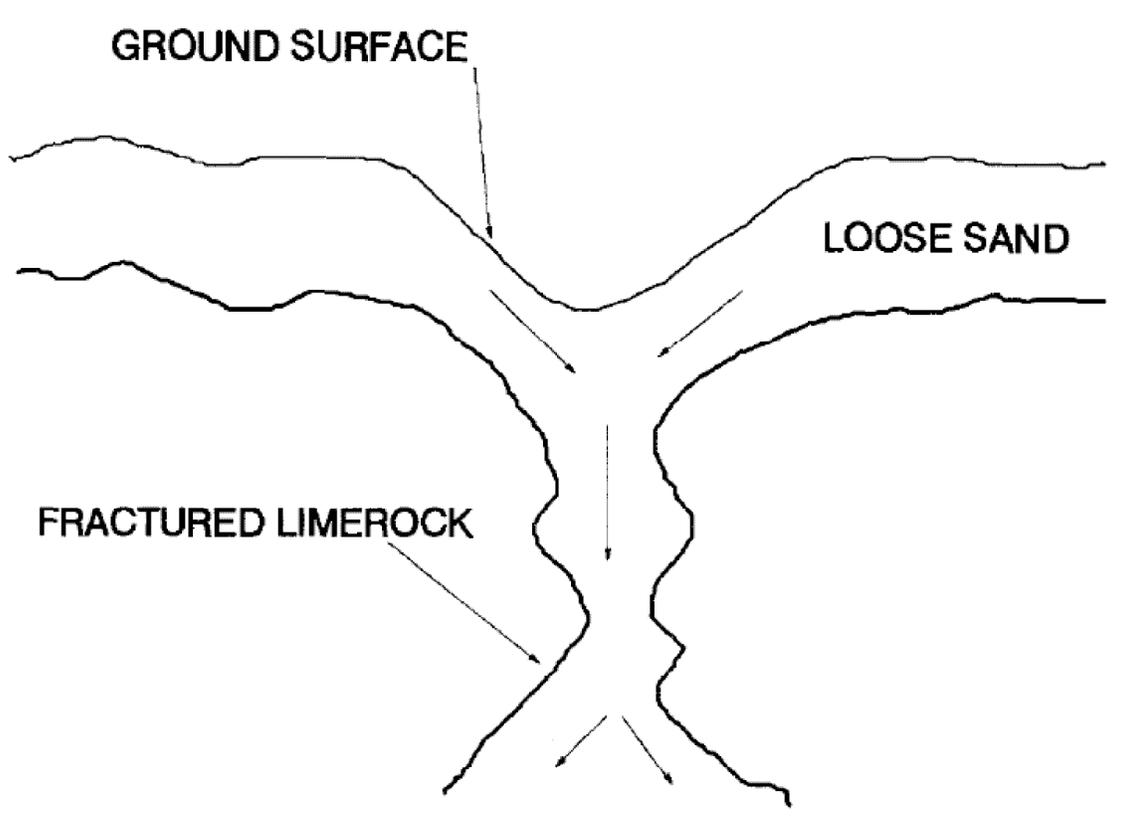
The area around Chiefland, along with other portions of North Florida, is classified as karst terrain, and is strongly prone to sinkhole development. The subsurface rock formations show as strongly pinnacled limerock outcroppings. The locally occurring sinkholes are of two types. The first is a slow raveling of sand into cavities in the underlying limerock, similar to sand running through an hourglass, which results in subsidence of the ground surface. This type of sinkhole can occur over a few hours, a few days, or a few weeks. The second type shows as a sudden collapse of soil into cavities in the limerock. The cohesion of the clayey soils above the cavity allows the surface to bridge over the subsurface cavity until it suddenly collapses into the cavity. These sinkhole types are shown in Figs. 1 and 2. The large house-swallowing type sinkholes, which are often reported in the mass media, do not occur in this area.

FIG. 1. Raveling-Type Sinkhole

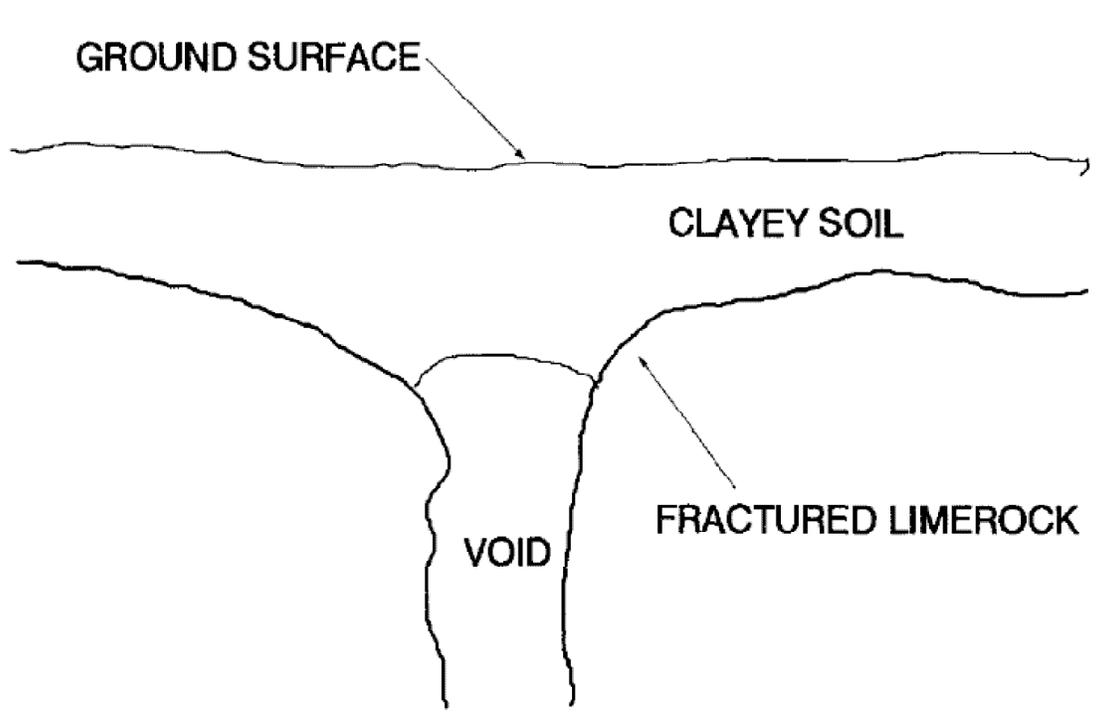
FIG. 2. Sudden-Collapse-Type Sinkhole

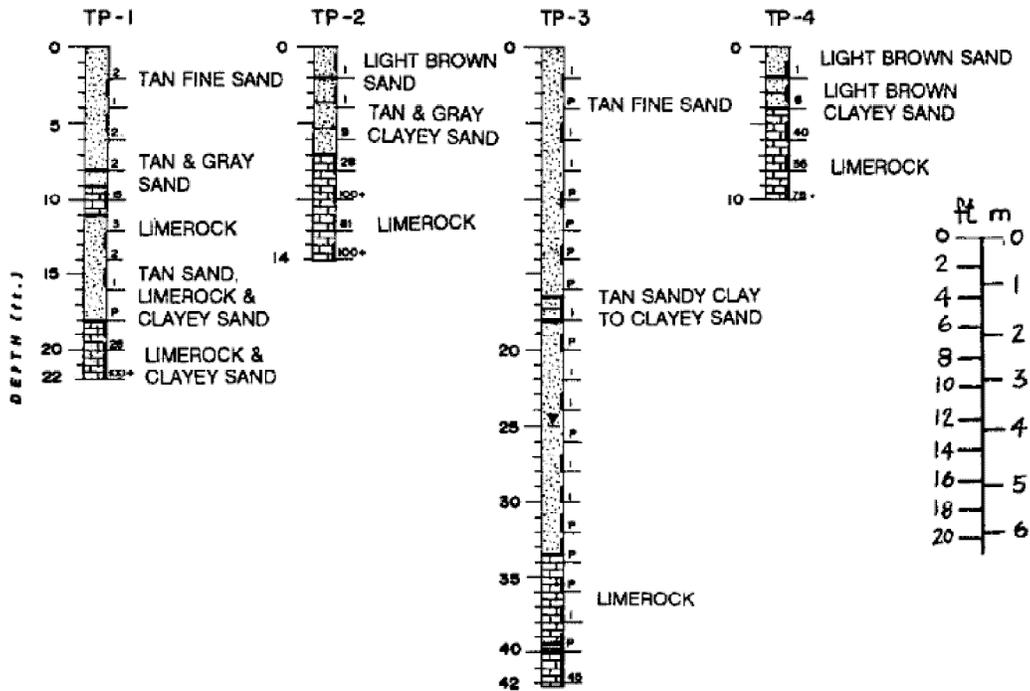
Soil borings and ground-penetration radar determined that a depression in the limerock beneath the surface was present in the area under the problem classrooms. The borings in this area generally found loose sand and clayey sand over limerock. The limerock was depressed under the classrooms, with the resulting bowl filled with very loose sand and clayey sand. The soil in the bowl had almost no resistance to the sampler,

indicating that the soil was eroding into a fracture in the limerock. These loose soils are referred to as raveled soils. Probing was not able to find the exact location of the fracture, but this is not surprising since these holes can be quite small, on the order of less than half a meter in diameter. Boring logs for this area are shown in Fig. 3. Designations above the logs are the hole numbers. Standard penetration blow counts are shown to the right of the log.

FIG 3. Boring Logs

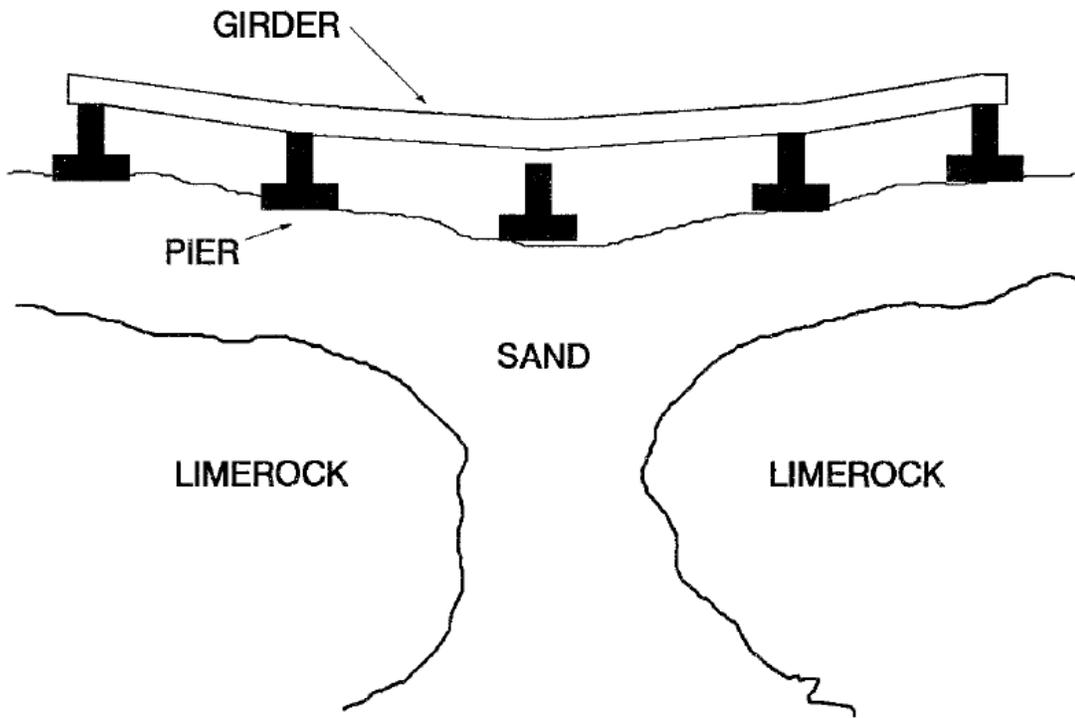
At the time of inspection on 2 April 1991, the structural damage to the building resulting from the sinkhole was limited to the area immediately around the classrooms in the north wing. An inspection beneath the building revealed the extent of damage to the foundation system as shown in Fig. 4. A total of eighteen piers appeared to be affected by the subsidence, with damage being confined to the footings and brick piers. Above the floor, the wall separating the classrooms was cracked and settled (Fig. 5), and the ceiling above was cracked, also. The actual cost of structural repairs for this phase would be fairly modest, provided that the footings could be leveled again on firm support.

FIG. 4. Typical Settlement Damage Caused by Sinkhole

The geotechnical engineers formulated a recommended repair method to close off the current sinkhole. This plan consisted of injecting low-slump concrete grout under pressure through steel pipes to seal off the fractures and cavity related to the sinkhole. This grouting would form a cap above the sinkhole. After grouting was completed, underpinning of the foundations would occur. A pipe pile would be inserted beneath each foundation. This pipe would be jacked against the foundation until it hit the limerock or hardened grout, thereby resupporting the foundation.

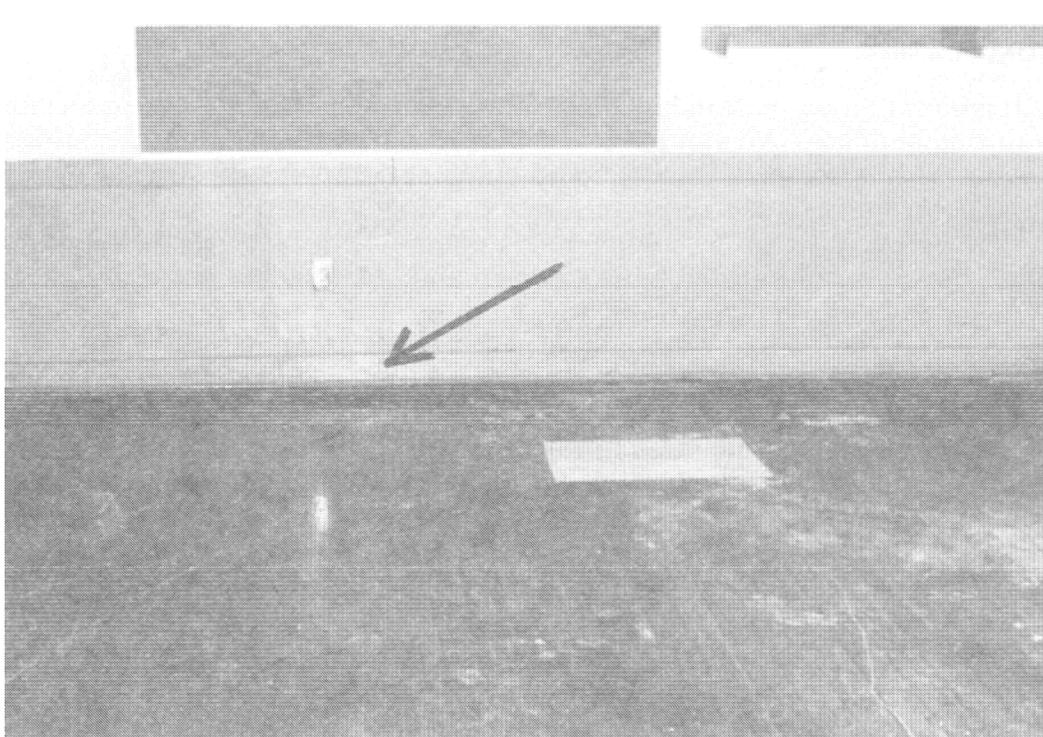
During the weekend, several sinkholes of both types occurred near the school football field, approximately 1000 feet to the west of the building. On Monday, 4 March 1991, faculty members discovered that the interior walls in two classrooms in the north wing of the building had separated from the floors, and that the floors did not feel solid. School maintenance employees opened access plates through the floor, and the foundations were inspected. It was discovered that several of the interior piers had settled several centimeters, and some were not in contact with the floor girders.

FIG. 5. Floor Settlement--Note Separation of Wall from Floor
