FORESNICS - METAL BUILDING COLLAPSE DURING ERECTION

Thomas Sputo, Ph.D., P.E., S.E.

CASE STUDY: METAL BUILDING COLLAPSE

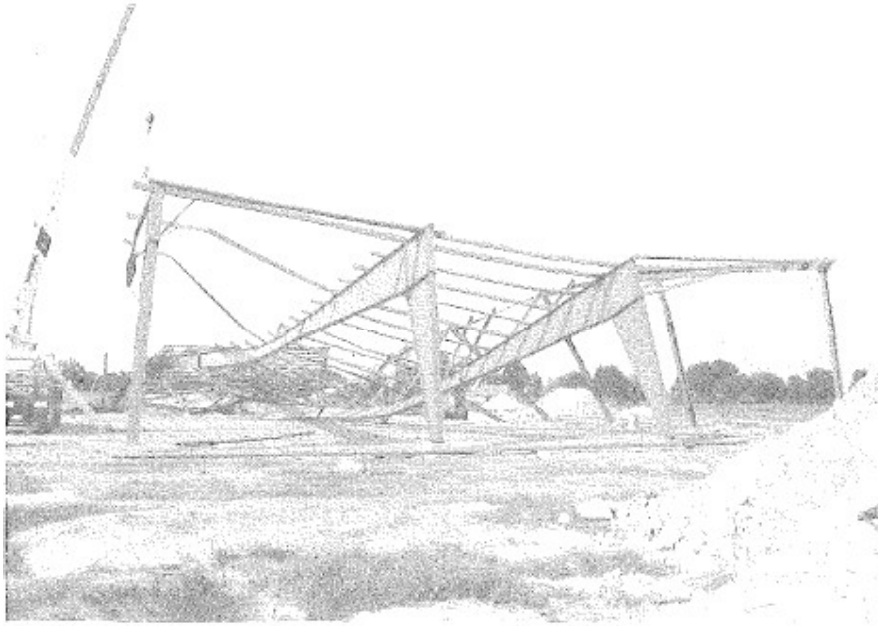
The structure suffered extensive damage, causing most of the erected steel to be scrapped. Figs. 2, 3, and 4 show the extent of damage to the structural steel. The foundations were also extensively damaged (as shown in Fig. 5), requiring major repairs.

FIG. 2. Collapsed Rigid Frames

The most likely cause of the collapse was instability of the rigid frames caused by the lack of bracing in the plane of the roof and sidewalls during erection. The erection drawings clearly showed full bracing in the plane of the roof and sidewalls, between the first two main bents, at this stage of erection. "MBMA Common Industry Practices" [section 6.2.1 of (Low 1986)] additionally notes that:

It appears that the 206 ft (62.8 m) rafters, without the roof bracing and flange stays being installed, became marginally unstable under dead weight alone. At this point of incipient instability only a slight force would have been necessary to precipitate buckling and collapse of the frames. That force could have been as slight as a 5 mi/hr (8 km/hr) wind, a bump while installing the third frame, or perhaps uneven heating from the sun shining on only one side of the rafter.

Since metal building systems are most vulnerable to collapse during erection, the building erector must take extreme care during this phase. The erector should have a copy of the manufacturers' erection manual on site and refer to it as erection progresses. All bracing called for on the erection drawings should be installed as in the drawings and the erection manual. Additional temporary bracing should be installed as required by the building configuration or site conditions. If the erector has any question as to the need for additional temporary bracing, the services of a structural engineer familiar with metal building systems should be engaged.

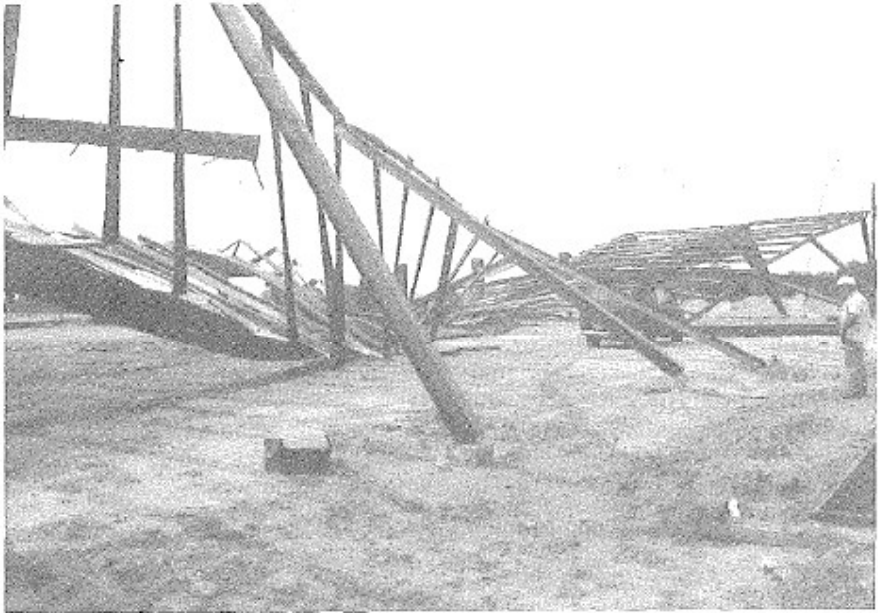
FIG. 3. Collapsed Post-and-Beam End Wall

Once the frames began to buckle and lean, all forces were transmitted through the only installed cross bracing into the two corner end wall foundations. It is little wonder that these end wall foundations, being designed for only 4 kips (17.8 kN) of thrust, were unable to support the structure. As a result, the entire end wall was pulled down with the rest of the structure.

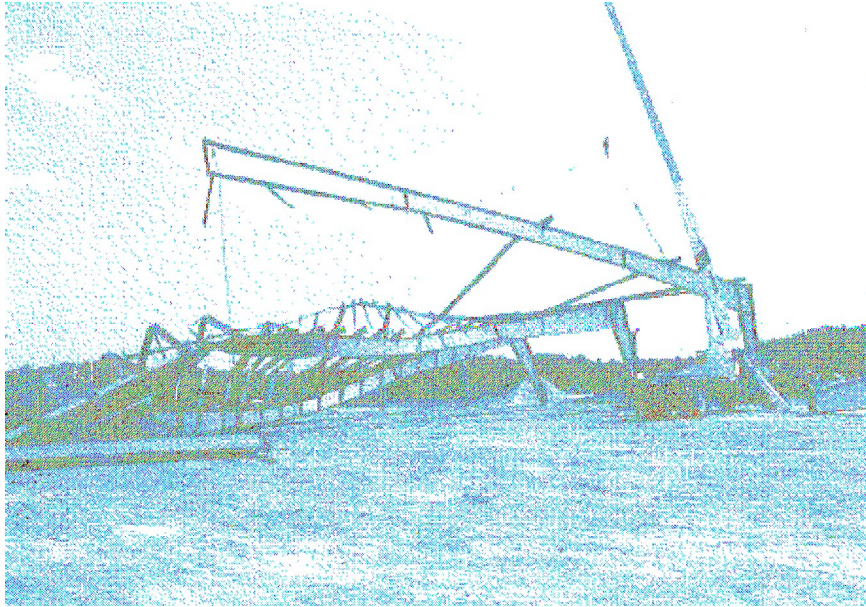
wind immediately prior to the collapse. Part of the third frame was attached to the rest of the structure by two purlins between the second and third frames. Fortunately, no loss of life or injury occurred.

FIG. 4. Partially Erected Third Rigid Frame

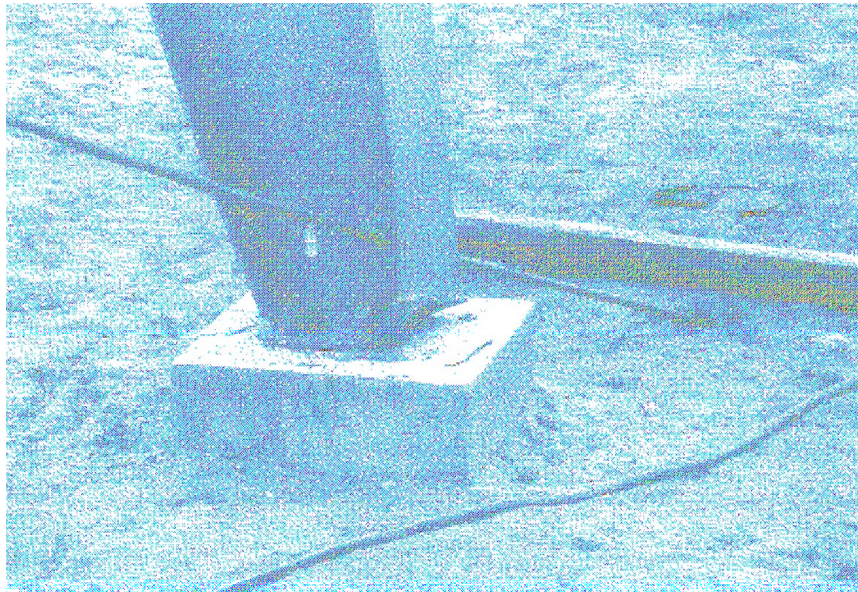
FIG. 5. Damaged Foundation for Rigid Frame
