FORESNICS - METAL BUILDING COLLAPSE DURING ERECTION

Thomas Sputo, Ph.D., P.E., S.E.

CASE STUDY: METAL BUILDING COLLAPSE

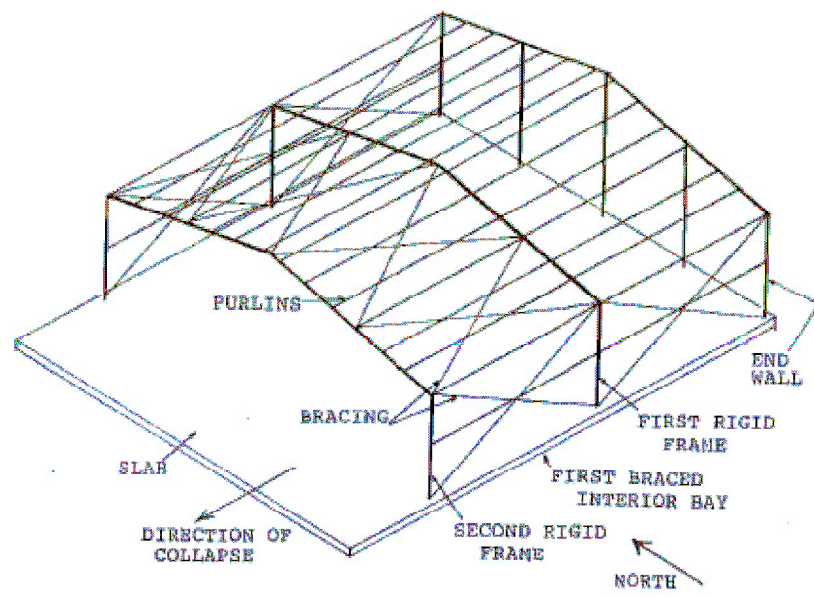
Normal erection procedure for a building of this type is to first erect the first braced interior bay, installing all sidewall and roof bracing, then erect and brace the end wall in its plane, then brace the endwall back to the interior bay, supplementing the manufacturer's bracing with temporary bracing as necessary (Fig. 1).

FIG. 1. Metal Building System Nomenclature
